Manhole Inspection Summary

Manhole # S19E1_007MH

Insp Date: **2/19/09 1:04 PM**

Location Address: **2801 MAUDLIN AV**

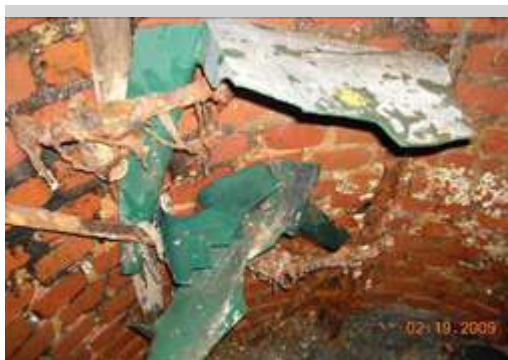
MISC.

PLASTIC DEBRIS THAT BLOCKED 12 OCLOCK PIPE

Comments **REMOVED DEBRIS FROM 12 OCLOCK PIPE TO ALEAVIATE SURCHARGE**

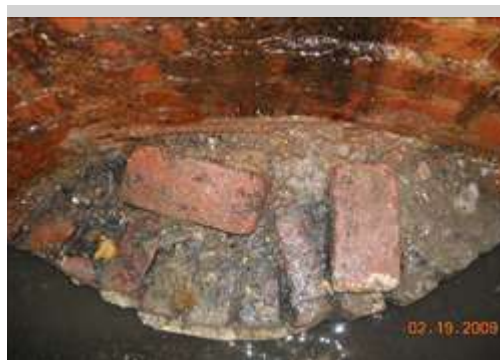
Defect 3

Condition: ☐ Sound ☐ Cracked ☐ Root Intrusion ☒ **Deteriorated** ☐ Leaks ☒ **Debris**

DEBRIS ON BENCH, bench deteriorated

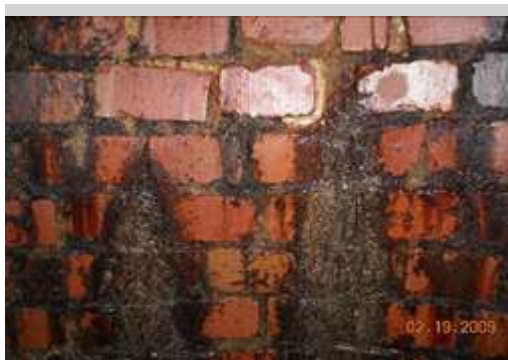
Defect 2

Infiltration: ☐ None ☐ Joint ☐ Cracks ☐ Mortar ☐ Roots ☒ **Wall**

INFILTRATION @ BARREL WALL

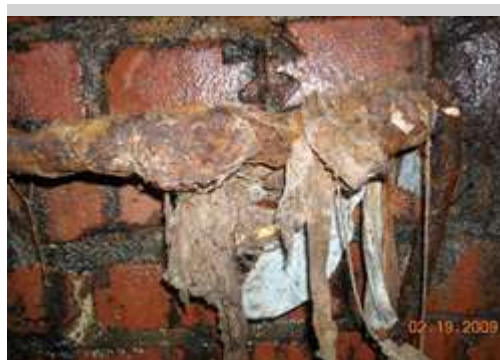
Defect 1

☒ **Evidence Of Surcharge** Depth: **4** (ft.) ☐ Active Surcharge Present

SURCHARGE EVIDENCE

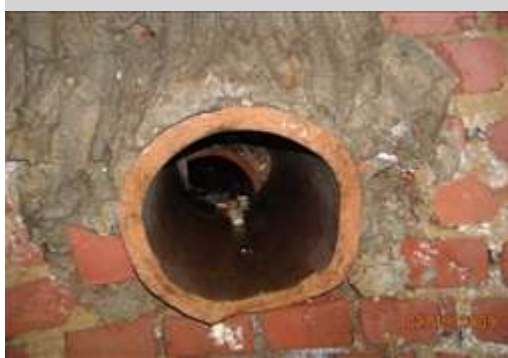
Defect

Condition: ☐ Sound ☐ Cracked ☐ Root Intrusion ☐ Loose Brick ☒ **Deteriorated**

barrel deteriorated

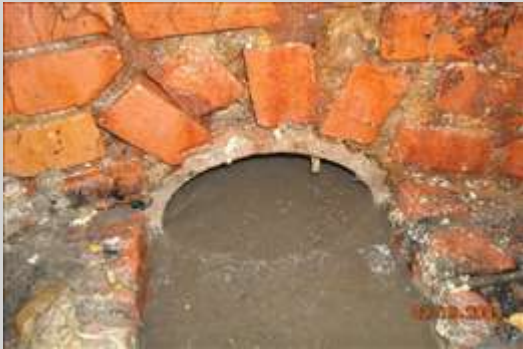
12 O'Clock Outflow

Pipe Height: **10.8** (in.) Rod and Bar (Angled)
Pipe Material: **Clay** ☐ Pipe Lined
Invert Depth: **18.15** (ft.) Flow Characteristics: **Slow**
Deposits: ☐ None ☒ **Mud** ☐ Sludge ☐ Debris ☐ Grease
Silt Depth: **2** (in.) Deposits Extent: **Light**
Infiltration: **None** Pipe Seal Cond: **Sound**

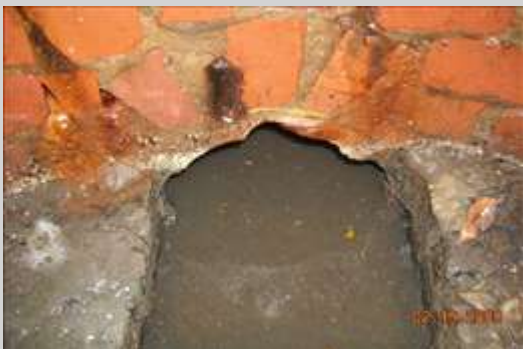
3 O'Clock Inflow

Pipe Height: **10.8** (in.) Rod and Bar (Angled)
Pipe Material: **Clay** ☐ Pipe Lined
Invert Depth: **18.00** (ft.) Flow Characteristics: **Slow**
Deposits: ☒ None ☐ Mud ☐ Sludge ☐ Debris ☐ Grease
Silt Depth: **0** (in.) Deposits Extent:
Infiltration: **Weeper** Pipe Seal Cond: **Sound**

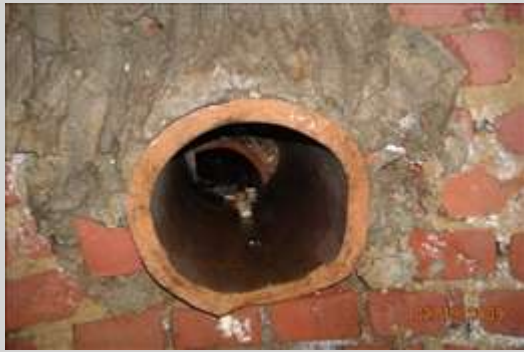
offset joint in pipe
